# Manhole Inspection Summary

Manhole # S23GG1024MH

Insp Date: **12/13/06 9:29 AM**

**Location** Address: **3976 EDGEHILL AVE**

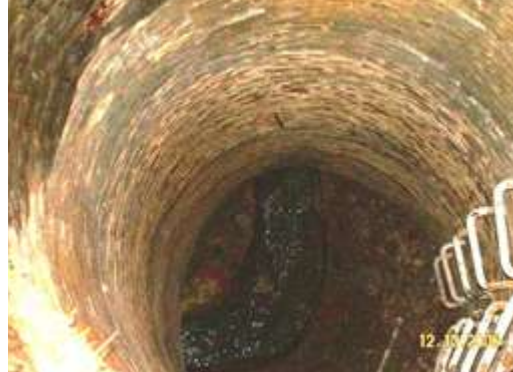
Top View

Adjustment, Corbel and Barrel infiltration.  
Bench debris.

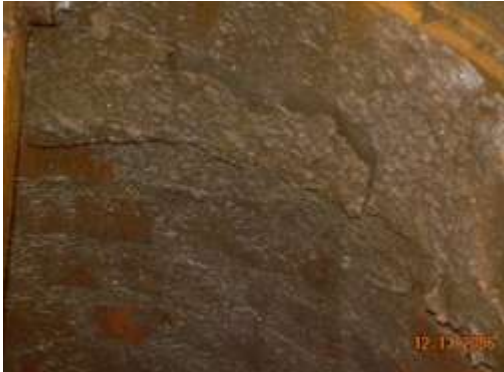
Defect

Frame leaks. Adjustment infiltration.

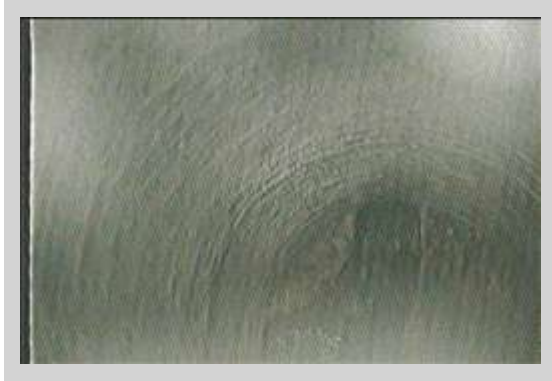
### 12 in. Circular Gravity Sewer Pipe Out @ 12 O'Clock

Invert Depth: **25.13** (ft.) Flow Characteristics: **Fast**

Deposits: ☒ None ☐ Mud ☐ Sludge ☐ Debris ☐ Grease

Infiltration: **None** Pipe Seal Cond: **Unknown**

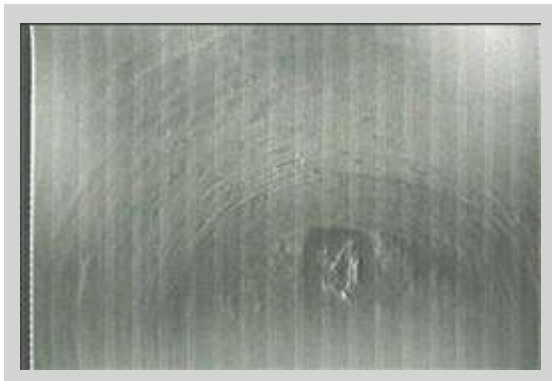
### 12 in. Circular Gravity Sewer Pipe In @ 9 O'Clock

Invert Depth: **24.84** (ft.) Flow Characteristics: **Fast**

Deposits: ☒ None ☐ Mud ☐ Sludge ☐ Debris ☐ Grease

Infiltration: **None** Pipe Seal Cond: **Unknown**
